Case Report

Refrigerator Blast: A Rare Explosion Fatality

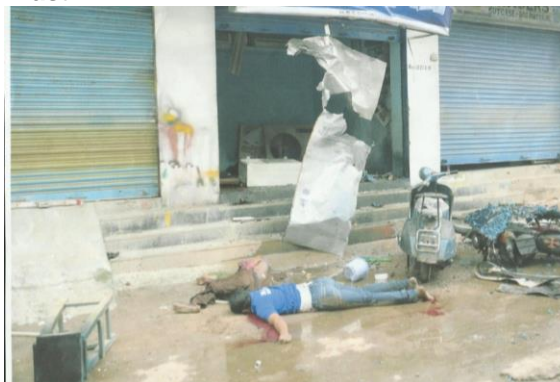
Both the youngsters sustained blast injuries and succumbed to severe disruptive injury on the spot. (Fig.1) The impact of the blast was so severe that the fridge dismembered into smithereens, ceiling fan and window panes were shattered into pieces.

Fig. 1: Dead Bodied of Victim at Scene of Blast

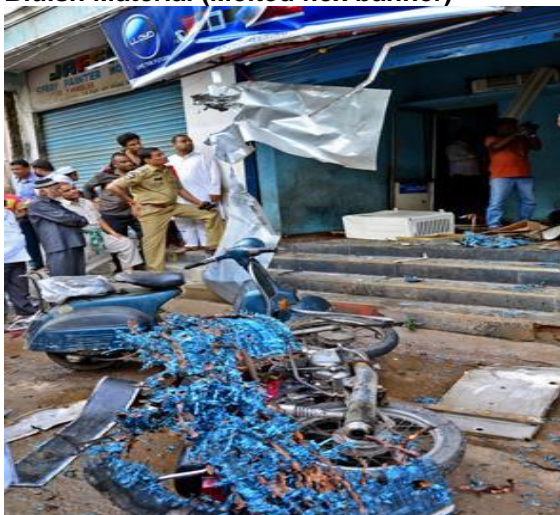
They ran out till the gate and collapsed. One of the vehicles parked outside the workshop was knocked down due to explosion and was layered with bluish color material [melted flex banner]. (Fig. 2)

Fig. 2: Knocked Down Motor Bile Layer with Bluish Material (Melted flex banner)

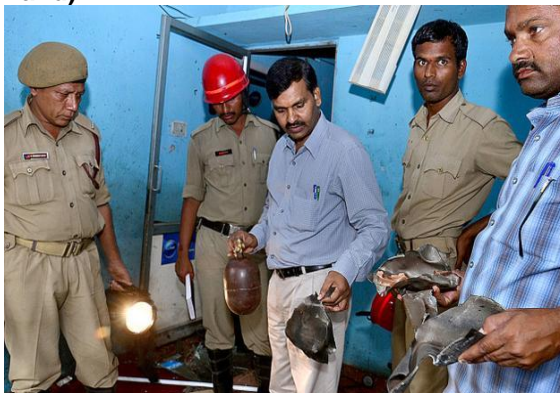
Surprisingly the compressor tank was found intact amongst the debris of blast. (Fig. 3)

Fig. 3: Investigating Officer Inspecting Debris (Left Hand) and Intact Gas Cylinder (right hand)

The samples collected from the scene of blast; analyzed at FSL by the flame Halide lamp test [A blue flame indicates the presence of normal gas while the green flame indicates the presence of chlorine] demonstrated the presence of chlorinated compounds. Traces of alumina (Al_2O_3) were also found at the site.

The recovered material from the explosion site also showed the presence of chlorinated compounds and traces of alumina (Al_2O_3). So far as prevention of such explosion
