Case Report

Unusual Fatal Bitemporal Crushing Head injury By Industrial Baler Machine

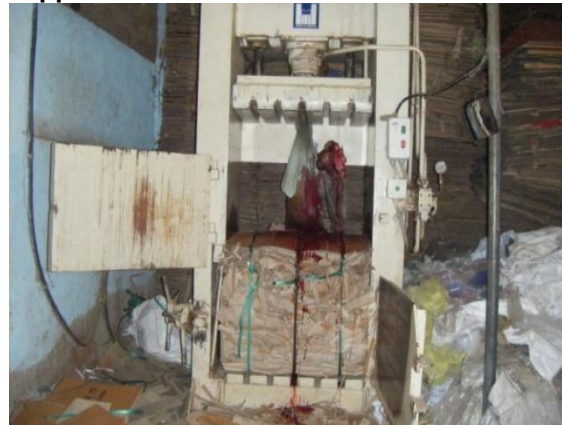
Fig. 6: Scene of Accident Showing the Body trapped in Situ in Baler Machine

His hand was seen caught in the machine; and there was nobody else in the unit at that time and as such the victim had been alone at the time the incident happened. It was also observed that the victim had not been wearing any safety headgear in the form of a helmet. From the position of the body as seen in the photograph, the following sequence of events is reconstructed by the authors.

The right upper limb of the victim got trapped in between the platen (the horizontal slab of metal that moves up and down and causes compression of the scrap material) and the body of the baler machine; and as he was unable to free his upper limb, his head was compressed in between the platen and the bale of scrap that was placed within the baler machine. The bale of scrap had been compressed and was tied with cords and ready for ejection from the machine.

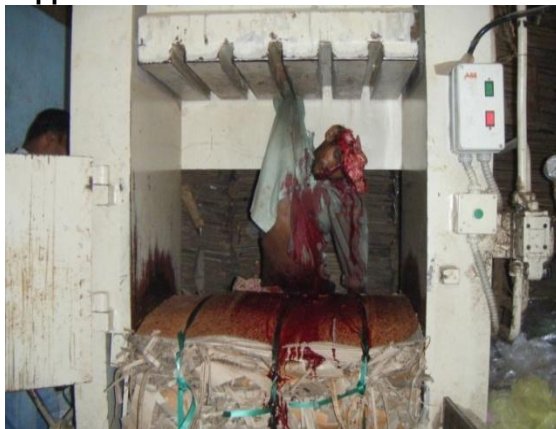
Fig. 5: Scene of Accident Showing the Body trapped in Situ in Baler Machine
